1
NASA Technical Memorandum 78912

Application of Multispectral Scanner Data to the Study of an Abandoned Surface Coal Mine

Ernie W. Spisz

NOVEMBER 1978

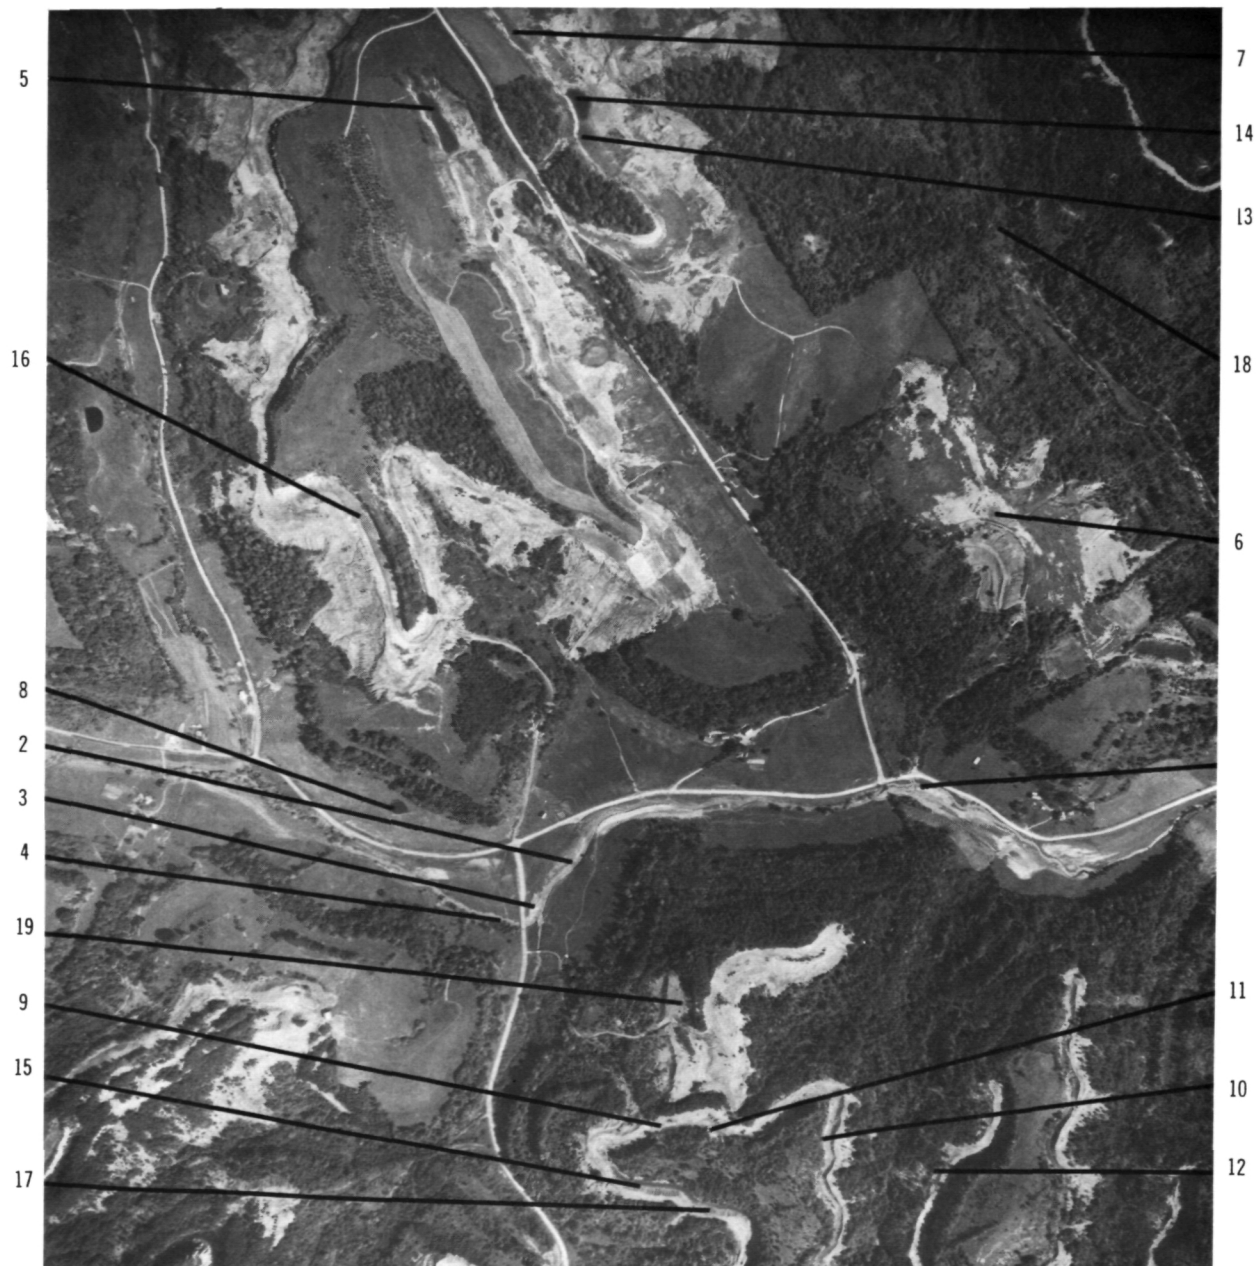
Figure 28. - Training-site locations - March surface-water study.

The locations of the training sites for the March surface-water study are shown in figure 28. The training-site description and the pH and radiometric data are presented in table XII. The March radiometric data are like the September data in that they are tightly clustered, as indicated by the small standard deviation and the high eigenvalues. The March radiometric data range, however, is larger than the September range because of the contribution of the shallow, sediment-laden stream. The 0.6-kilometer altitude at which the March data were obtained was much more suited to the extraction of surface-water data.
